# Grouting the foundation of Evinos dam in Greece

I.F. Fikiris & G.T. Dounias  
EDAFOS Engineering Consultants Ltd, Athens, Greece

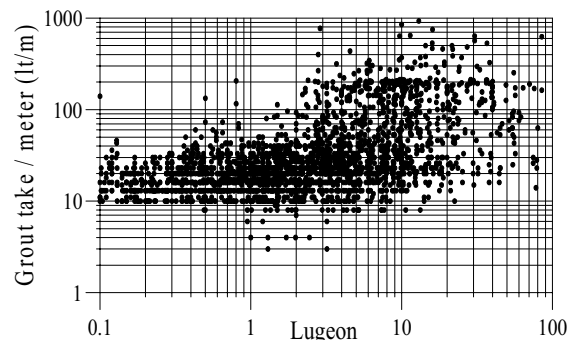
Figure 4 Grout take vs permeability values (2546 data)

No relation exists between water permeability and grout take (fig.4). Therefore, the conception prevails in the literature that proportional relationships between permeability and grout take are not to be expected.
